SHIVKALIN PANI SATHAVAN YOJANA

SUCCESS STORY of VILLAGE TASGAON, KOLHAPUR

SUCCESS STORY of VILLAGE AMBAPWADI, KOLHAPUR

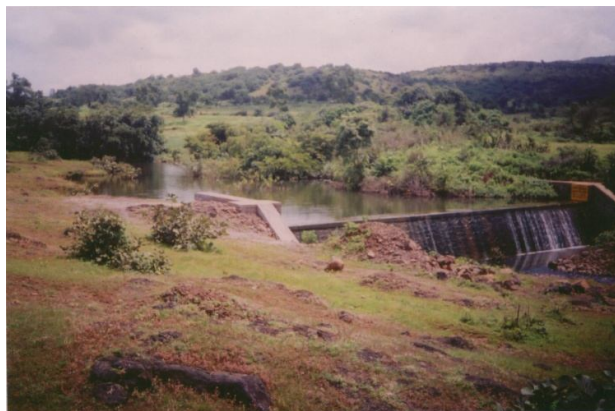
Cement Nala Bandh
Village- Tasgaon Tal - Hatkanangale

- i) Bore well recharge through RTRWH
- ii) C.N.B. on local stream (2)

After artificial recharge of existing bore wells with roof top rainwater harvesting and construction of 2 C.N.B. on local streams, water levels in the ground is observed to be increased and eventually the village became tanker free.

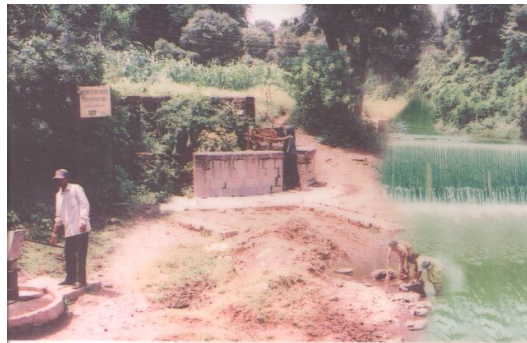
Cement Nalla Bandhara
Village – Ambapwadi Tal – Hatkanangale

| i) Cement nalla bandh (total 3 in no.) | Rs. 711800/- |

With the strengthening of water source, villagers are getting adequate water from P.W.S. well and nearby hand pumps saving their time and physical efforts. Village became tanker free after 2005.
